WASHINGTON CIRCLE ELEVATION

3 WASHINGTON CIRCLE FACADE

NEW HAMPSHIRE AVENUE ELEVATION

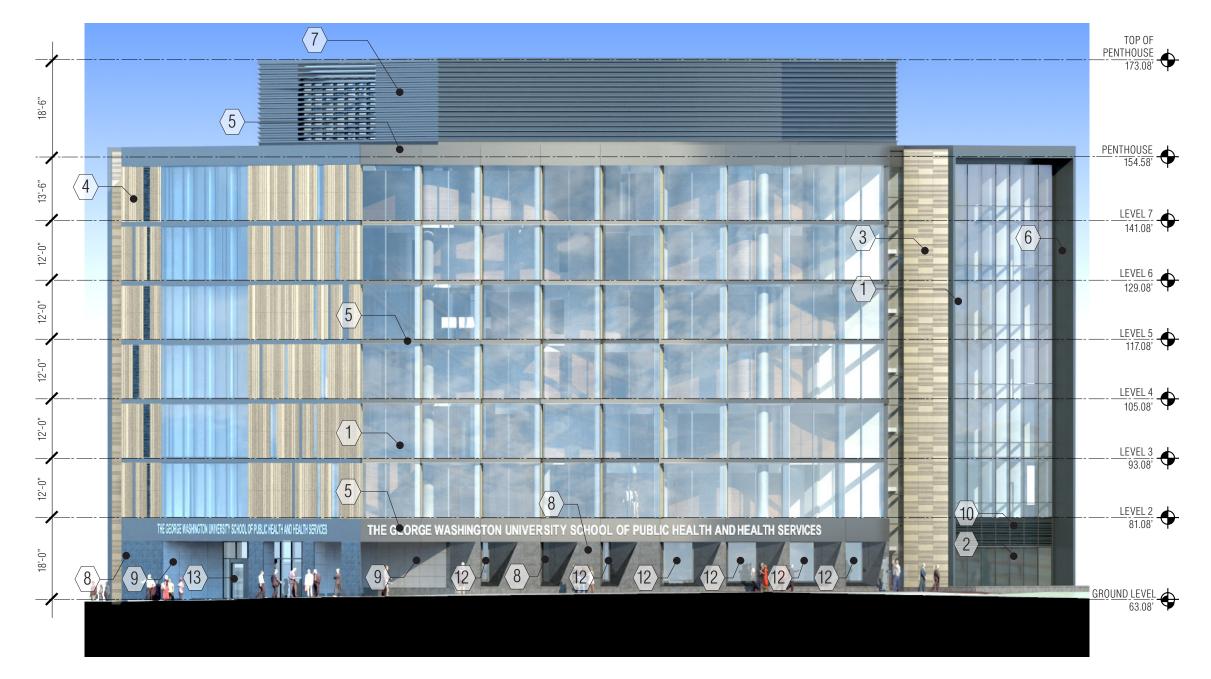
- $\overline{1}$ Aluminum Curtain Wall System
- $\langle 2 \rangle$ Spandrel Glass
- $\langle 3 \rangle$ Horizontal Terra Cotta Rainscreen Wall System
- $\overline{\langle 4 \rangle}$ Vertical Terra Cotta Rainscreen Wall System
- $\boxed{5} \, \text{Aluminum Trim}$
- 6 Aluminum Plate Panel
- $\overline{\left<7\right>}$ Profiled Metal Panel Wall
- 8 Granite Wall Cladding
- 9 Limestone Wall Cladding
- (10) Mechanical Louver
- $\langle 11 \rangle$ Aluminum Sun Shade
- (12) Aluminum Window
- $\langle \overline{13} \rangle$ Aluminum Entrance Door
- (14) Coiling Metal Service Door

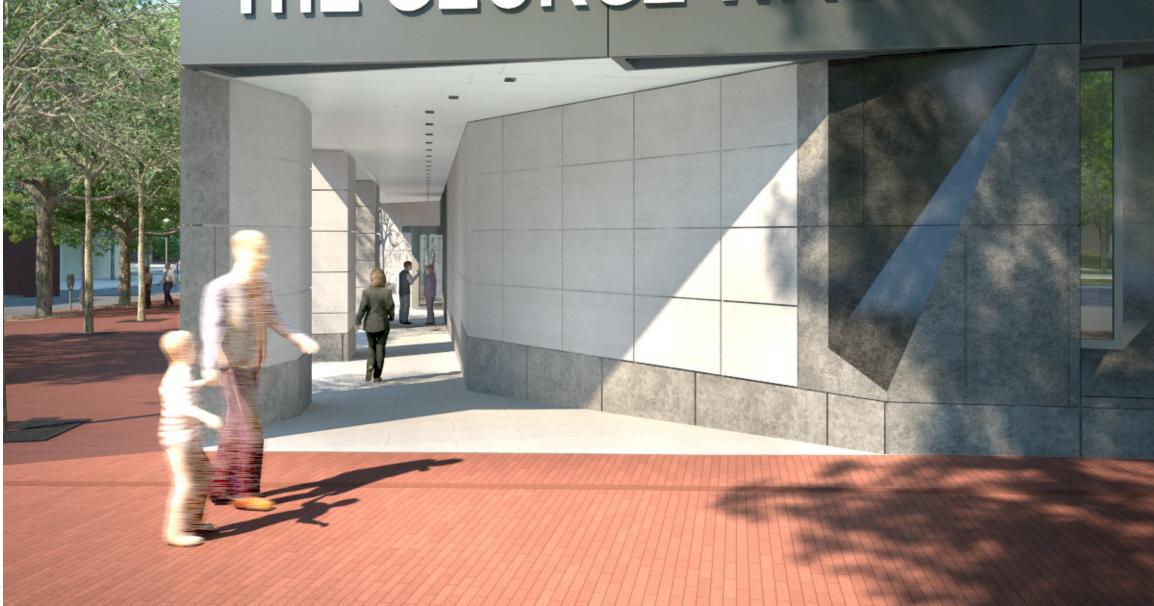
PERSPECTIVE VIEW TOWARDS ENTRY FROM WASHINGTON CIRCLE SIDEWALK LOOKING SOUTHWEST

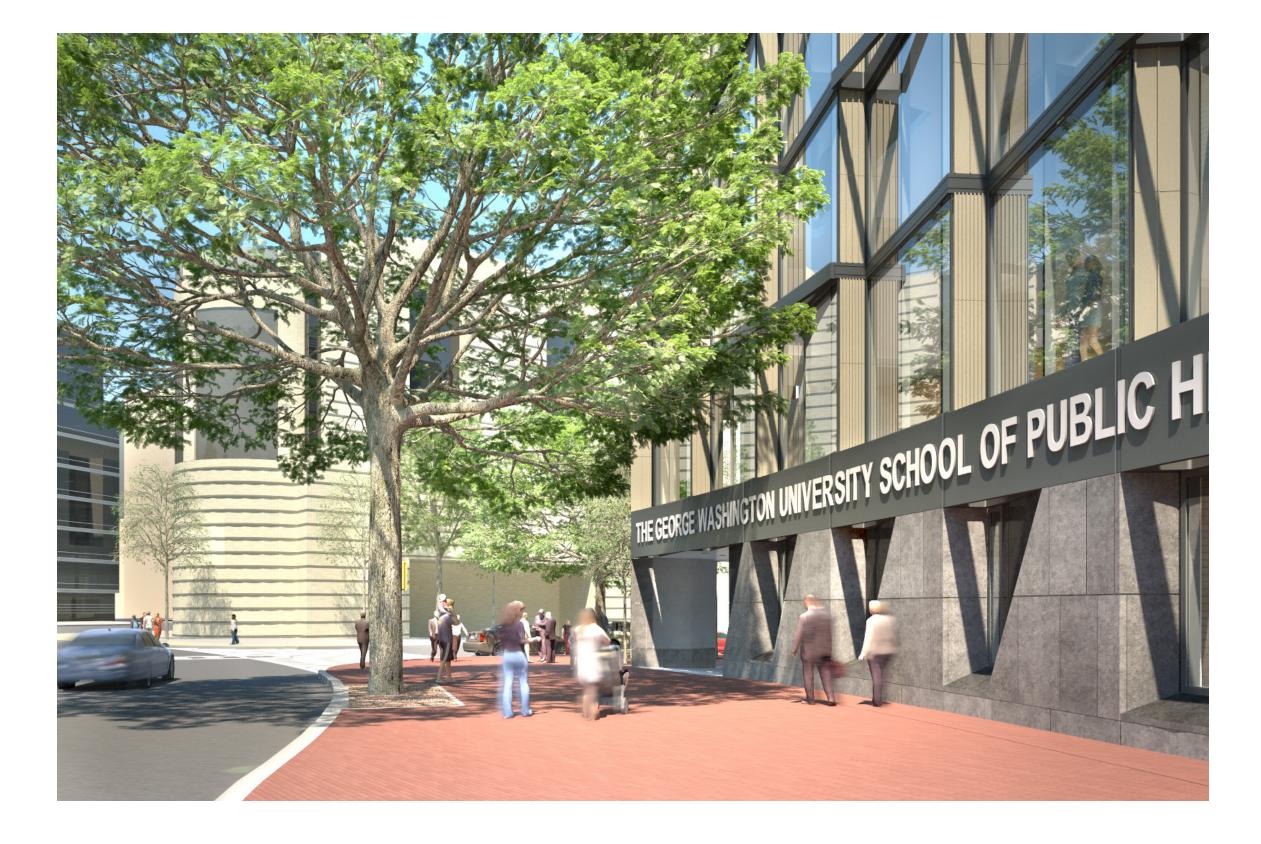
PERSPECTIVE VIEW OF SIDEWALK ALONG WASHINGTON CIRCLE LOOKING EAST

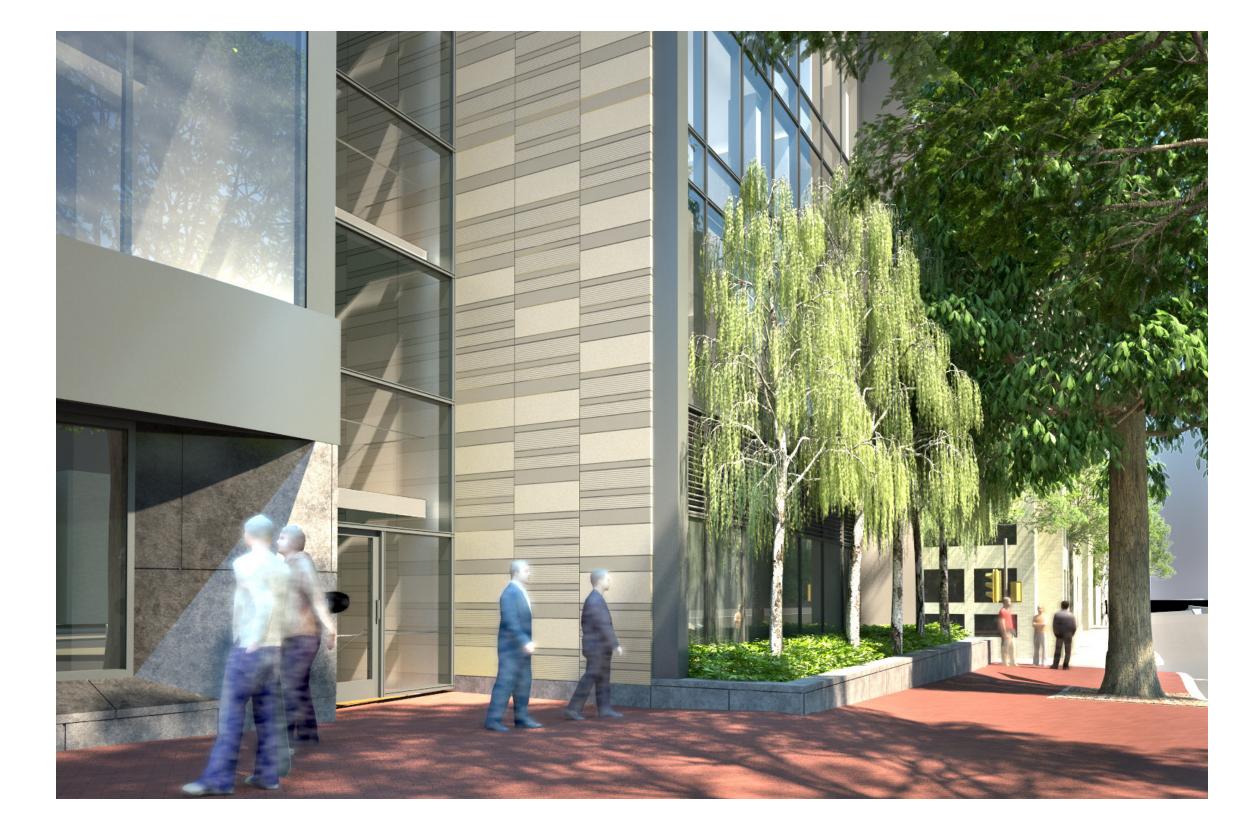
PERSPECTIVE VIEW OF SIDEWALK ALONG WASHINGTON CIRCLE LOOKING WEST

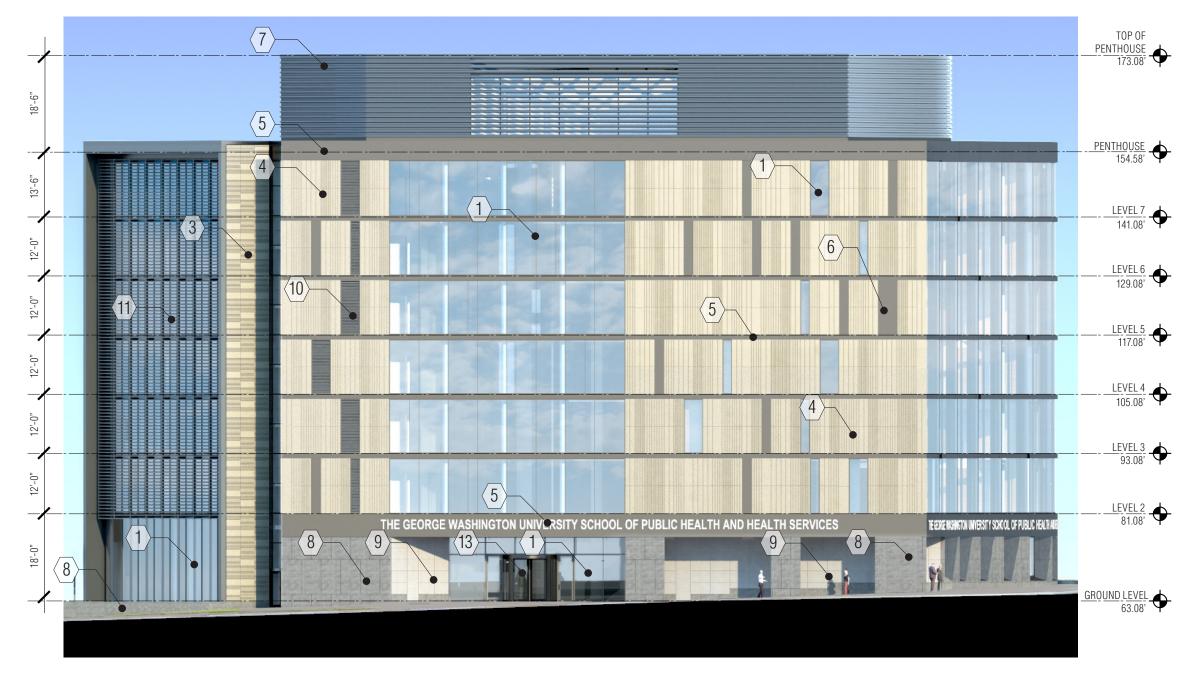
- $\langle 1 \rangle$ Aluminum Curtain Wall System
- $\langle 2 \rangle$ Spandrel Glass
- $\langle 3 \rangle$ Horizontal Terra Cotta Rainscreen Wall System
- $\overline{\langle 4 \rangle}$ Vertical Terra Cotta Rainscreen Wall System
- $\langle 5 \rangle$ Aluminum Trim
- $\overline{6}$ Aluminum Plate Panel
- $\langle 7 \rangle$ Profiled Metal Panel Wall
- 8 Granite Wall Cladding
- 9 Limestone Wall Cladding
- (10) Mechanical Louver
- $\langle 11 \rangle$ Aluminum Sun Shade
- (12) Aluminum Window
- $\langle \overline{13} \rangle$ Aluminum Entrance Door
- (14) Coiling Metal Service Door
